# **MANDATORY SERVICE BULLETIN**

**Bulletin MSB-0001**

Issue Date 02/11/2011 Rev. -

### **SUBJECT:**

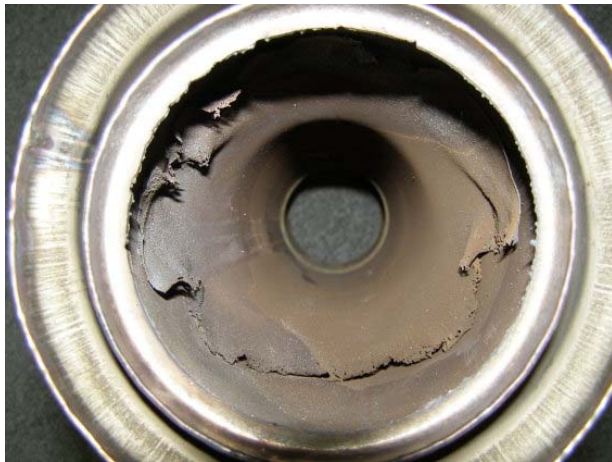
**C&D Heater**

Two low time examples are pictured here with the end dome removed. The pictures show burned out sections of the center flame tube. This flame tube deterioration then allows the concentrated

heat to weaken the sealed chamber wall causing the tube to rupture. The first is a C&D heater with 560 hours time in service. The second is a Janitrol factory remanufactured heater with 184 hours time in service.

Cause of the heaters premature failure has been identified to include design of the aircraft heat distribution and undependable fuel control to the heater. C&D has elected to recall all Piper Chieftain PA-31-350, heater part number CD14048 (-1) to be returned to the factory for inspection and modification. Modification of the heater will eliminate combustion chamber rupture when the aircraft heating system modification kit CD29151 is installed to improve air flow and stabilize fuel to the heater.

1. Prior to the next flight,
  - a. Complete a pressure decay test (PDT) in accordance with C&D maintenance manual MM10001.
    - i. In the event that the heater fails PDT, contact C&D prior to further operation.

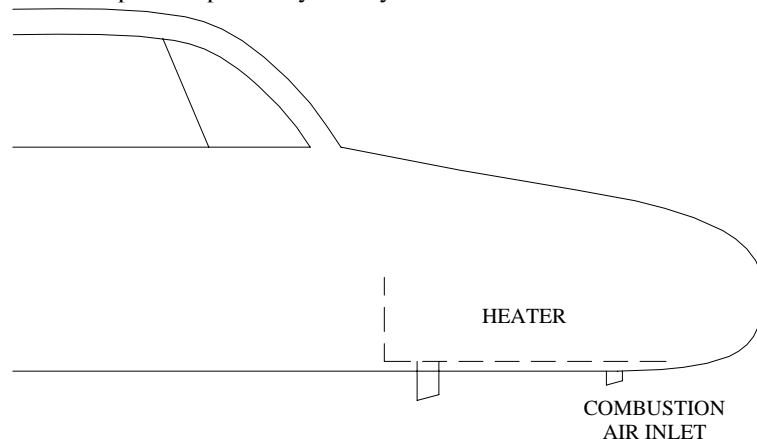
FIGURE 1

1. Preparation:
  - A. Follow the Aircraft Service Manual or other FAA approved source for removal of the existing Combustion Heater.
  - B. Install the C&D Associates, Inc. TSO-C20 Approved Combustion Heater utilizing the existing Aircraft Service Manual or other FAA approved source where applicable.
2. Combustion Air Inlet Modification:
  - A. For proper combustion air balance, combustion air inlet scoop (located forward of where heater exhaust pipe extends out of aircraft.) needs proper scarf (see fig. 1). This angle is 15 deg. with longer portion of scarf aft. Supplied inlet template (fig 2) can be cut out and taped around existing inlet, transfer angle with a marker. Trim and de-bur. Top of template may or may not reach to aircraft skin.

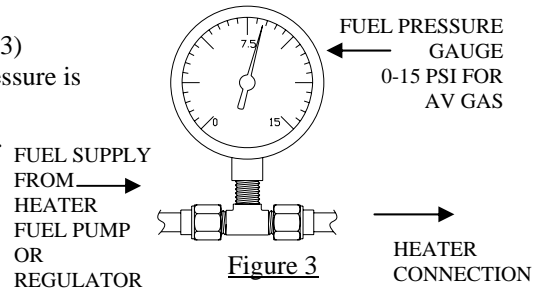
- C. Install the fuel pressure gauge (0-15). Tee into as shown. (Fig. 3)

- 1) With the heater running, verify fuel pressure. Preferred pressure is 8psi. (6.5psi min, 10psi max)
- 2) With the heater running, verify that the outlet plenum temp. is approx. 250°. Adjust the cycling switch if needed. Clock-wise to increase, counter-clock-wise to decrease temperature. (Fig. 5)

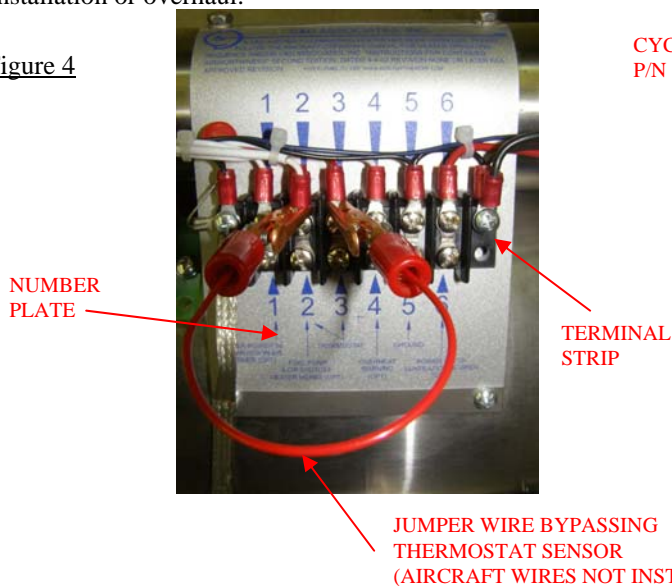
**Figure 4**

- B. Place a 6” 20G jumper wire with 2 small alligator clips (or the like) across the heater terminal strip numbers 2 and 3, which will bypass the aircraft thermostat. (Fig. 4)

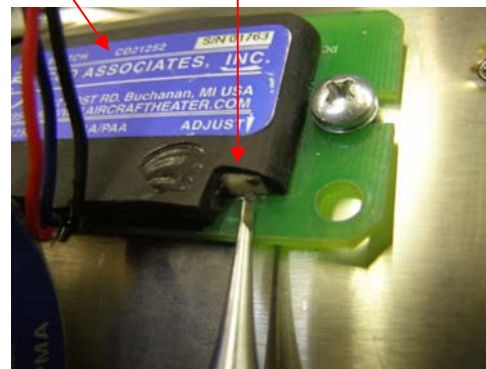
**Figure 5**

NOTE: Adjust screw no more than ¼ turn at a time.

**CYCLING SW. ADJUSTMENT**

**CYCLING SWITCH P/N 21252**
